## **Machias**

## East Machias at Factory Road

## WASHINGTON COUNTY COUNCIL OF GOVERNMENTS

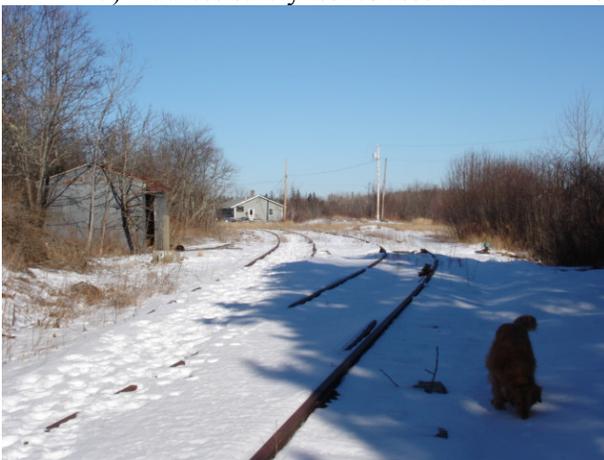
The maximum width dimension for onsite parking is about 50 feet; the siding extends parallel to the rails at that width for at least 200 ft. The siding narrows before crossing Factory Road, therefore, a short access road (approx 100 feet in length) from Factory Road to the parking area would be needed.

Adjacent to the site on Factory Road, there is a gravel parking area that appears to be overflow parking for medical offices across the street. An access road for trailhead parking would probably have to cross this existing parking area. There is also an unimproved ROW adjacent and possibly crossing the southern bounds of the site. Adjacent to the site on the southeast is a mound of earth with a protruding standpipe. There is also what appears to be an old utility shed on the site. Dumping and underground utilities do not appear to be issues at this site.

Looking east along toward Factory Road.

- 1) Research and address encroachment issues on the site's eastern bound.
- 2) Make use of the site's high visibility location with interpretive signage and trail maps.
- 3) Develop trailhead facilities including parking for at least 15 vehicles, a picnic area, and possibly public facilities;
- 4) Wayfinding signage from Route One and Route 191.
- 5) Address safety issues associated with Route 1 crossing.

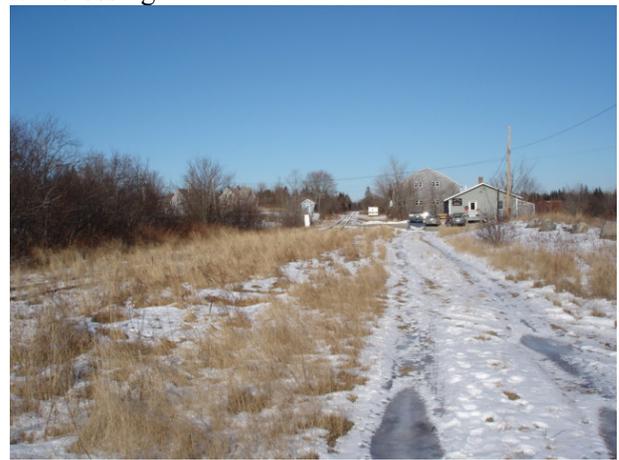
ROW and mound along south edge of siding.

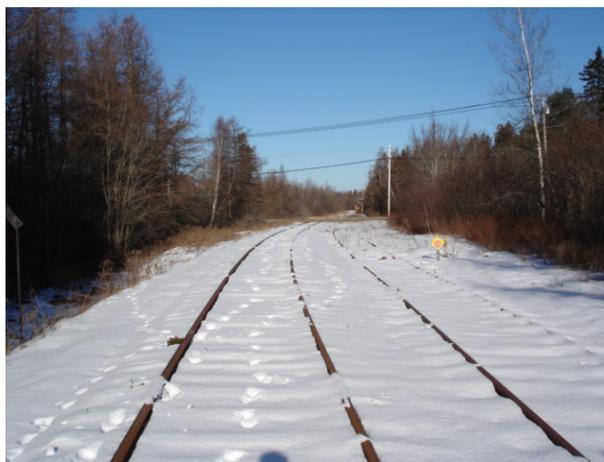
*Site Constraints:* The site is narrow and long, with a maximum width of less than 25 feet (excluding the trail corridor). The siding narrows before crossing Route 191, therefore, additional land may need to be acquired in order to widen the throat for vehicular entry. Sight lines along the Route 191 corridor provide good visual access for turning traffic.

The existing siding area is flat and will require little or no clearing. The site is surrounded on four sides by forested and semi-forested wetlands; however, the site itself is elevated above the level of surrounding wetlands and appears to be relatively dry. Development of this site may require wetland impacts, especially to open the throat for vehicular access to trailhead parking.

Looking east toward Route 191 along siding.

- 1) Widen throat for safe vehicular access.
- 2) Parking for snowmobile/ATV trailers.

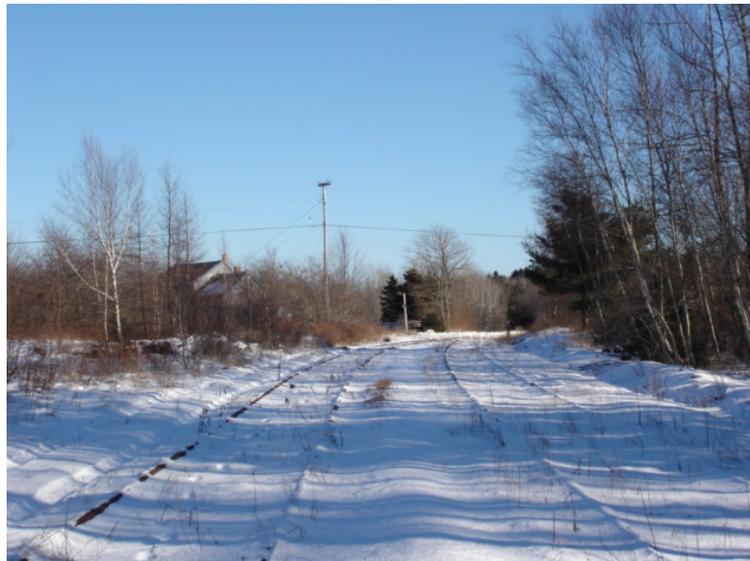
*Site Constraints:* The existing siding does not narrow before crossing Marion Station Road, therefore vehicular access directly onto trailhead parking would be relatively straight forward. Though the site is relatively narrow (approx. 30 feet), the length of the siding would provide ample room for parking. In addition, there would ample room for this site to accommodate a sheltered picnic areas and public facilities. Sight lines along the Marion Station Road corridor provide good visual access for turning traffic.

There is significant dumping along the north side of the trail corridor that would need to be cleared. Wetlands and underground utilities do not appear to be issues at this site.

Looking east from the former station area toward Marion Station Road.

- 1) Consider this site for subsequent development of a small parking area (~5 vehicles) and picnic area.
- 2) Wayfinding signage from Route 1 in Dennysville and East Machias and Route 191 in Marion Twp.

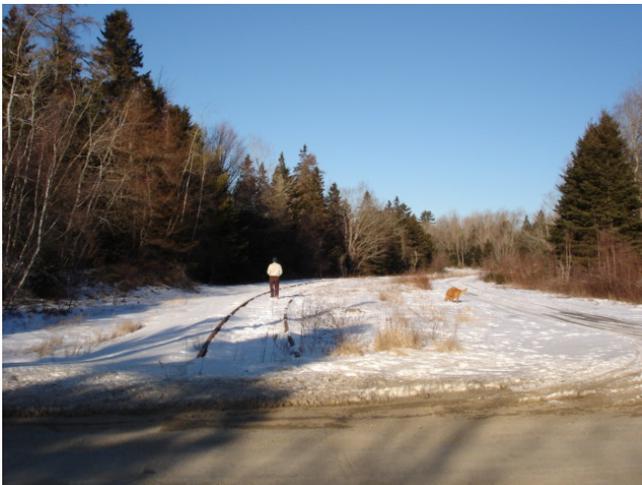
*Site Constraints:* The existing siding narrows before crossing King Street. An access road from King Street to the site would need to be secured. There appears to be sufficient room for a narrow access road parallel to the trail corridor. Sight lines along King Street corridor provide fair visual access for turning traffic.

The adjacent site of the former Dennysville Station is currently being used for storage of vehicles and excavating equipment; there is also a large, unstable gravel bank on the former station site. Both that station and an existing access road to the former station are posted as private; fencing may be needed to provide a buffer between the trailhead and the adjacent landowner. There may be encroachment issues with the existing ROW.

Rail corridor (left) and private ROW to former station (right).

- 1) Coordinate with ongoing trail planning in Dennysville.
- 2) Research and address potential encroachment issues with existing ROW.
- 3) Buffering to reduce visual nearby industrial uses should be considered.

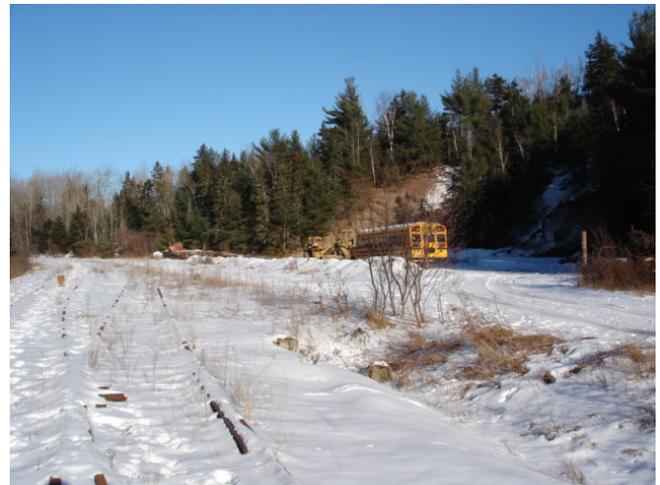
The existing siding area is flat and would require little or no clearing. There were no signs to indicate that the site itself is on a designated wetland, however the westerly edge of the site runs downhill to a stream; run-off may be a potential issue.

Siding area (left) and former station (right).

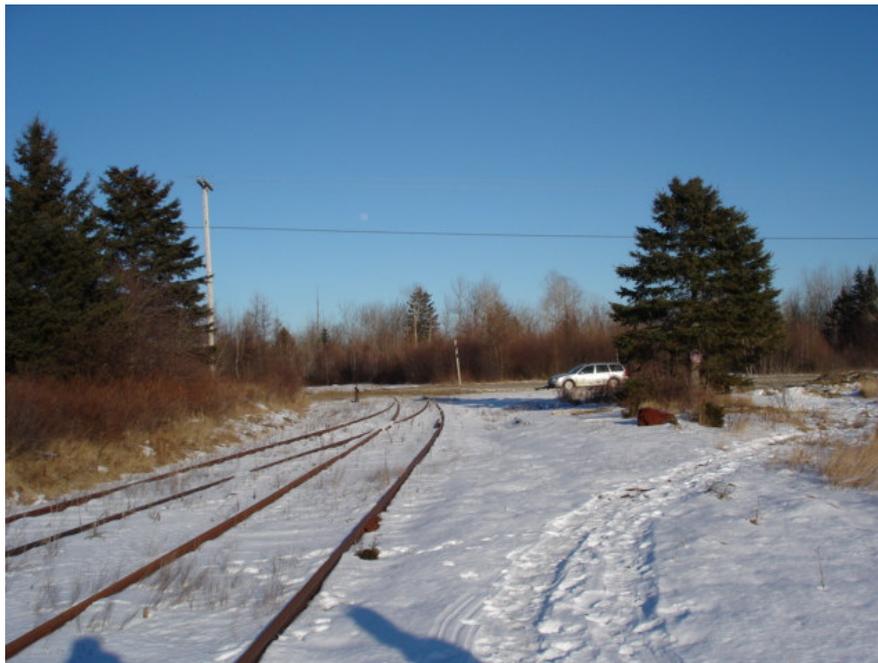
The existing siding does not narrow before crossing Route 214. The maximum width of the existing site exceeds 75 feet narrowing to a “V” 250+ feet south of Route 214. There is ample room for parking and other facilities at this location. Sight lines along Route 214 corridor provide good visual access for turning traffic.

*Site Constraints:* The existing siding area is flat and would require little or no clearing. There were no signs to indicate that the site itself is on a designated wetland, however there is a near by stream beyond the westerly edge of the site. The site itself sits in a low lying area and run-off impacts the stream and associated wetlands may be a potential issue.

Looking north toward Rt. 214 from the siding.

- 1) As the eastern terminus of the trail, this site should have interpretive signage and trail maps.
- 2) Public facilities and an emergency phone or pay phone should be considered.
- 3) Gravel parking area for 15 to 20 vehicles.
